RESEARCH ON GROWTH OF MICROCRACKS IN NICKEL-BASE SUPERALLOYS

Southwest Research Institute
P. O. Drawer 28510
San Antonio, Texas 78284

TECHNICAL REPORT AFML-TR-78-133
FINAL REPORT FOR PERIOD 1 JUNE 1976 to 30 SEPTEMBER 1978

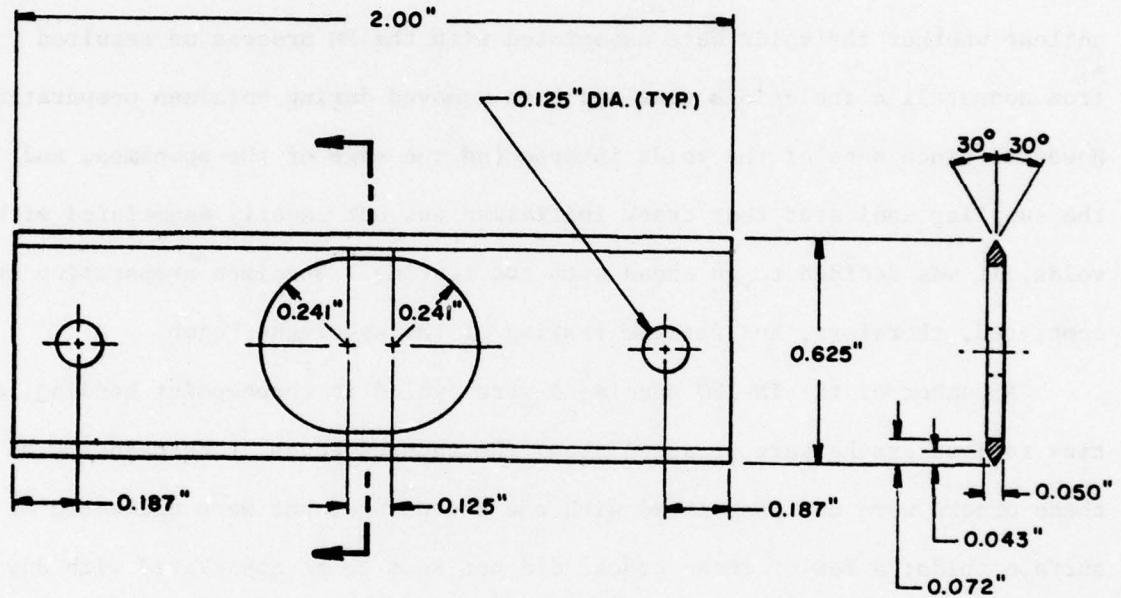
Figure 1. Schematic of Fatigue Specimen

Electro-Discharge Machining (EDM) to achieve the final configuration of Figure 1.

Although we were unable to propagate the cracks in bending, it was decided to go ahead and prepare a tensile specimen by enlarging the center hole to conform to Figure 1. This was done, and by carefully polishing away material at the tapered edge, we succeeded in placing the crack at the edge of the specimen. The final precrack was 12 microns long on the surface. The specimen was then cycled in tension with a stress range of 807.3 MPa (117 ksi) at $R = 0.05$ for 20,000 cycles. No growth was observed and the stress range was raised to 855.6 MPa (124 ksi). Following an additional 15,000 cycles, the specimen broke completely in half. The original fatigue crack did not extend during the test; the failure initiated at the edge of the center hole in the plane of the minimum section. At first it was thought that the failure originated at a surface scratch or a machine mark, but examination of the failure surface in the SEM showed the origin to be a subsurface void, approximately 0.025 mm in diameter. Surrounding the void was an area of crystallographic fracture; this was followed by an area of striations, and finally the dimpled region where ductile rupture began.

Briefly summarizing the specimen design considerations, the original specimen, Figure 1, was abandoned because of problems associated with the crack initiation process in the PM superalloy materials. Specifically, the presence of voids in the material made the prospect of initiating and growing a single microcrack at a specific location very risky. The second specimen, was designed to utilize an existing fatigue crack. The specimen, Figure 3, resulted from load shedding a SEN specimen and subsequently machining away material to leave only the crack tip, 0.06-0.16 mm long, in the test panel. This specimen was used for all crack propagation tests.

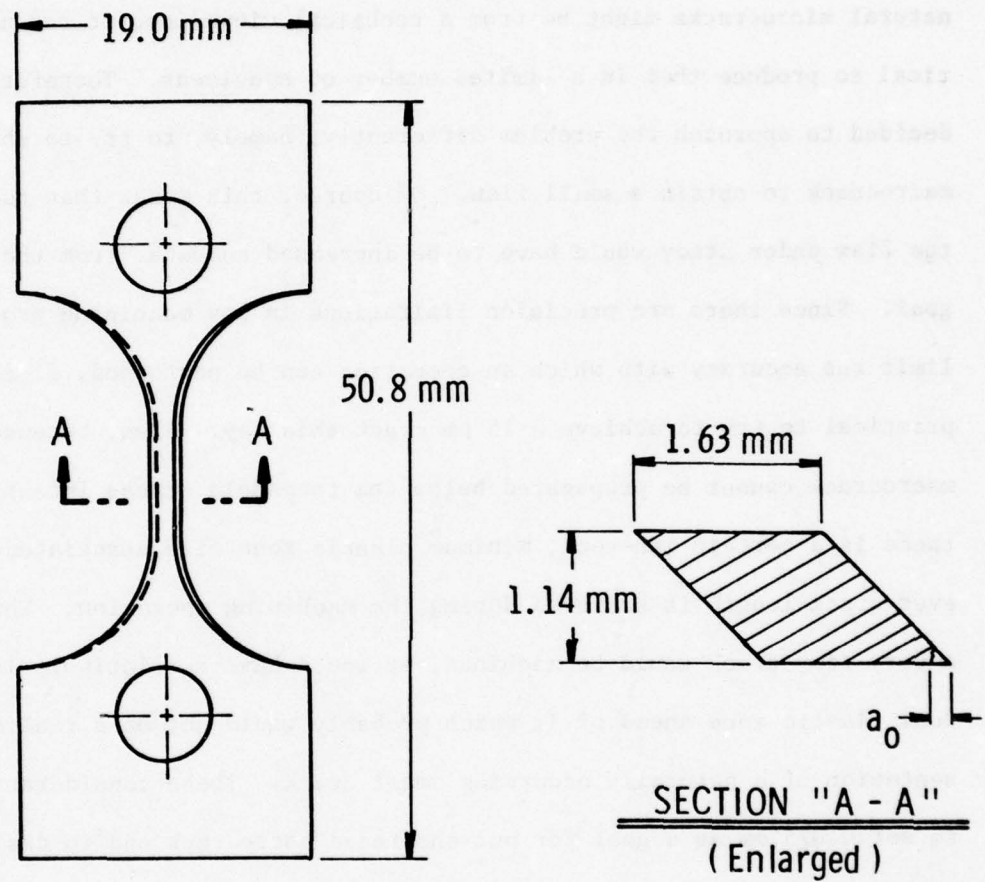
Figure 3. Final Fatigue Specimen Design

The second specimen designed in this program is shown in Figure 3. To obtain this configuration, a 19.05 mm wide, single edge notch specimen containing a machined notch of length 5.33 mm was cycled at 5 Hz, $R = 0.05$, to produce a fatigue crack approximately 2.29 mm long. The initial stress intensity range was about $\Delta K = 22 \text{ MPa}/\text{m}$, and as the crack grew, the load was successively reduced until the approximate room temperature threshold for IN-100, $8.8 \text{ MPa}/\text{m}$, was reached. During the load shedding operation, the crack growth rate was periodically monitored and found to agree with other investigators [2]. Once load shedding was complete, the specimen was then machined

and polished into the configuration shown in Figure 3. This was accomplished by electro-discharge machining away the bulk of the material and then removing the remainder of the material using progressively finer polishes. The final polish used was 0.05 micron alumina slurry. Cracks as short as 0.06 mm were produced in this fashion.

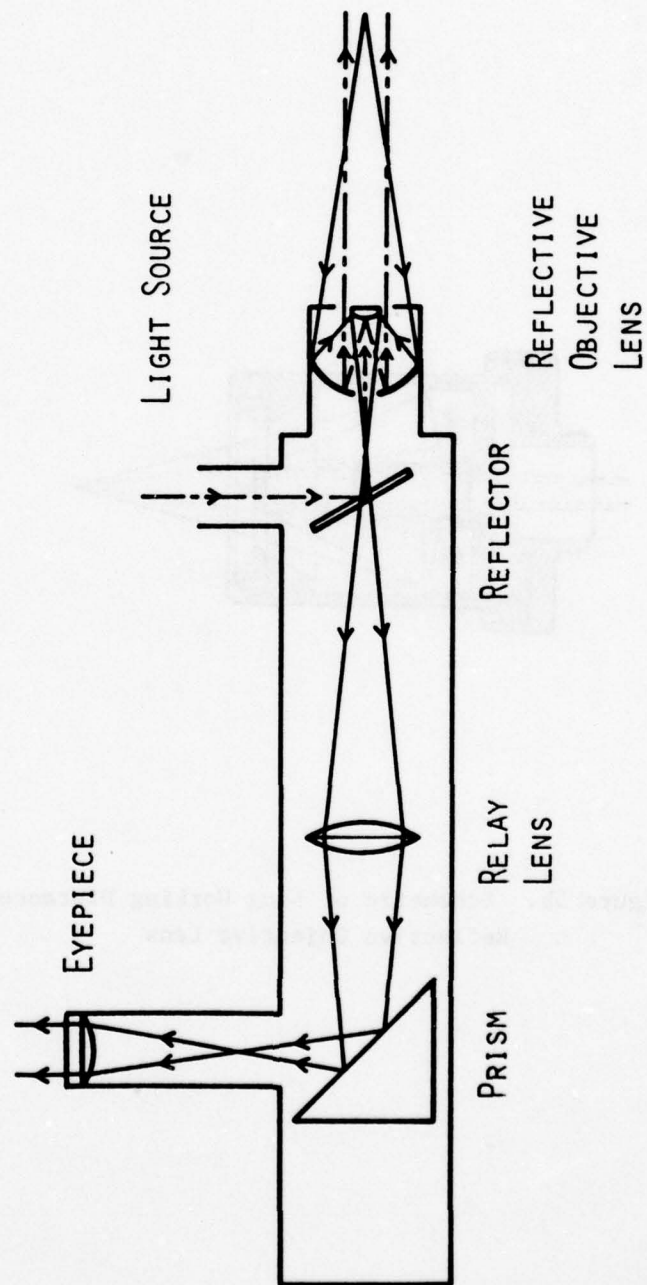
Figure 5a. Schematic of Long Working Distance Microscope

The resulting system is shown schematically in Figure 5a. The design is essentially a microscope within a microscope, in which the inner microscope focuses on the image of an objective lens and thereby produces the high magnification. The key element in the design is the objective lens itself. This lens is a 15X reflective objective manufactured by Beck Instrument Company and has a working distance of approximately 25 mm. This long working distance is achieved by use of parabolic mirrors instead of glass lenses; a sketch of the lens is shown in Figure 5b. The mirrors can be maintained at higher temperatures without fear of distortion or damage due to thermal

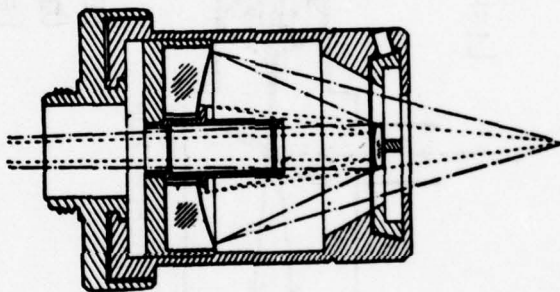
Figure 5b. Schematic of Long Working Distance
Reflective Objective Lens

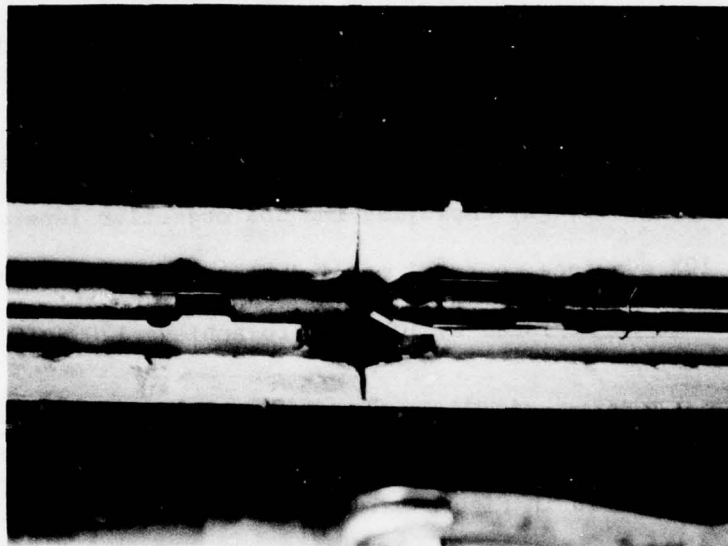
Figure 6b. Specimen and Grip Arrangement
In Furnace

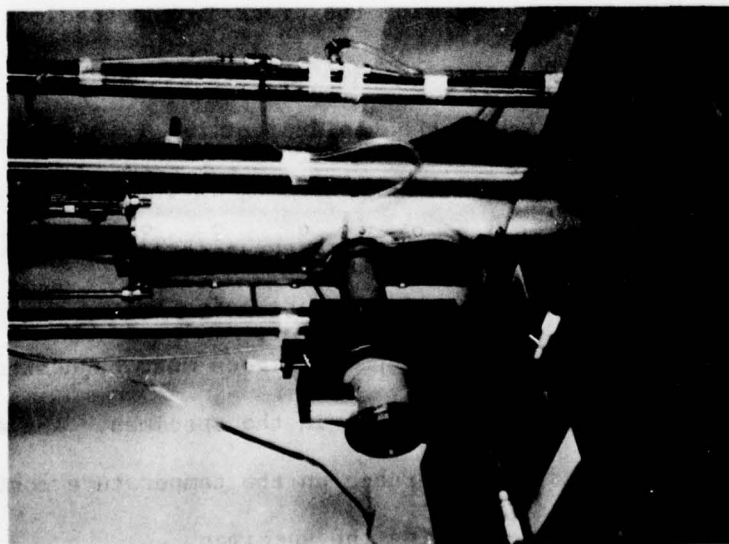
Figure 6a. Long Working Distance
Microscope Interfaced With
Furnace

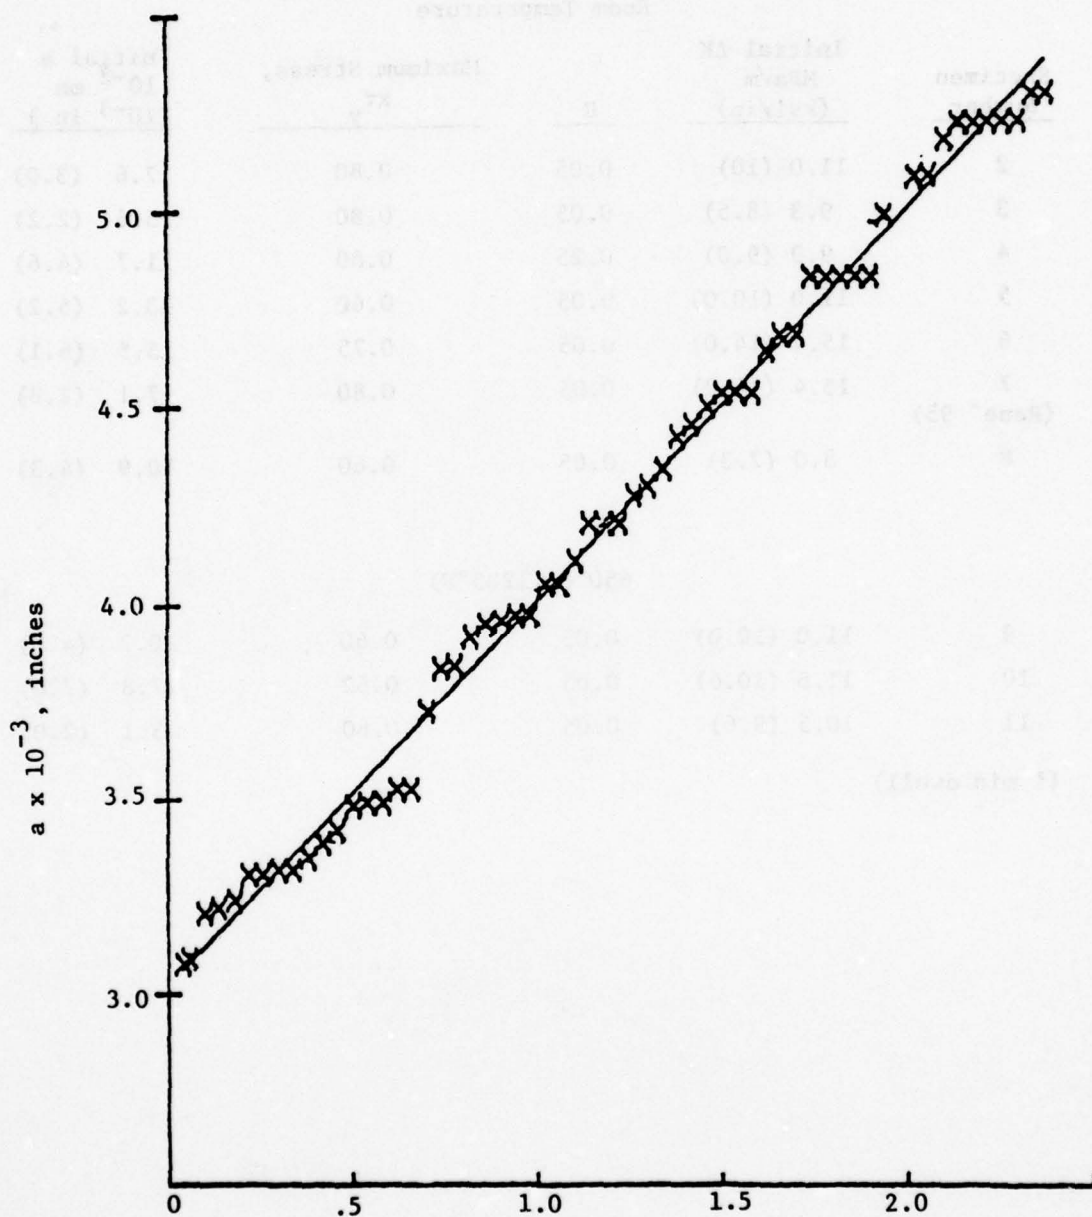
Figure 7. A Vs N Data of Specimen No. 2, R = 0.05.
(See Table 2 For Test Parameters)

When the entire test data are plotted on the same scale, the linear crack growth behavior exists at much longer crack lengths, although the slope becomes progressively steeper. That is, following a period of constant da/dN such as shown in Figure 7, there is a gradual transition to another constant slope region, but with a steeper slope. The discontinuous growth pattern also remained, even for cracks which would be termed macrocracks.

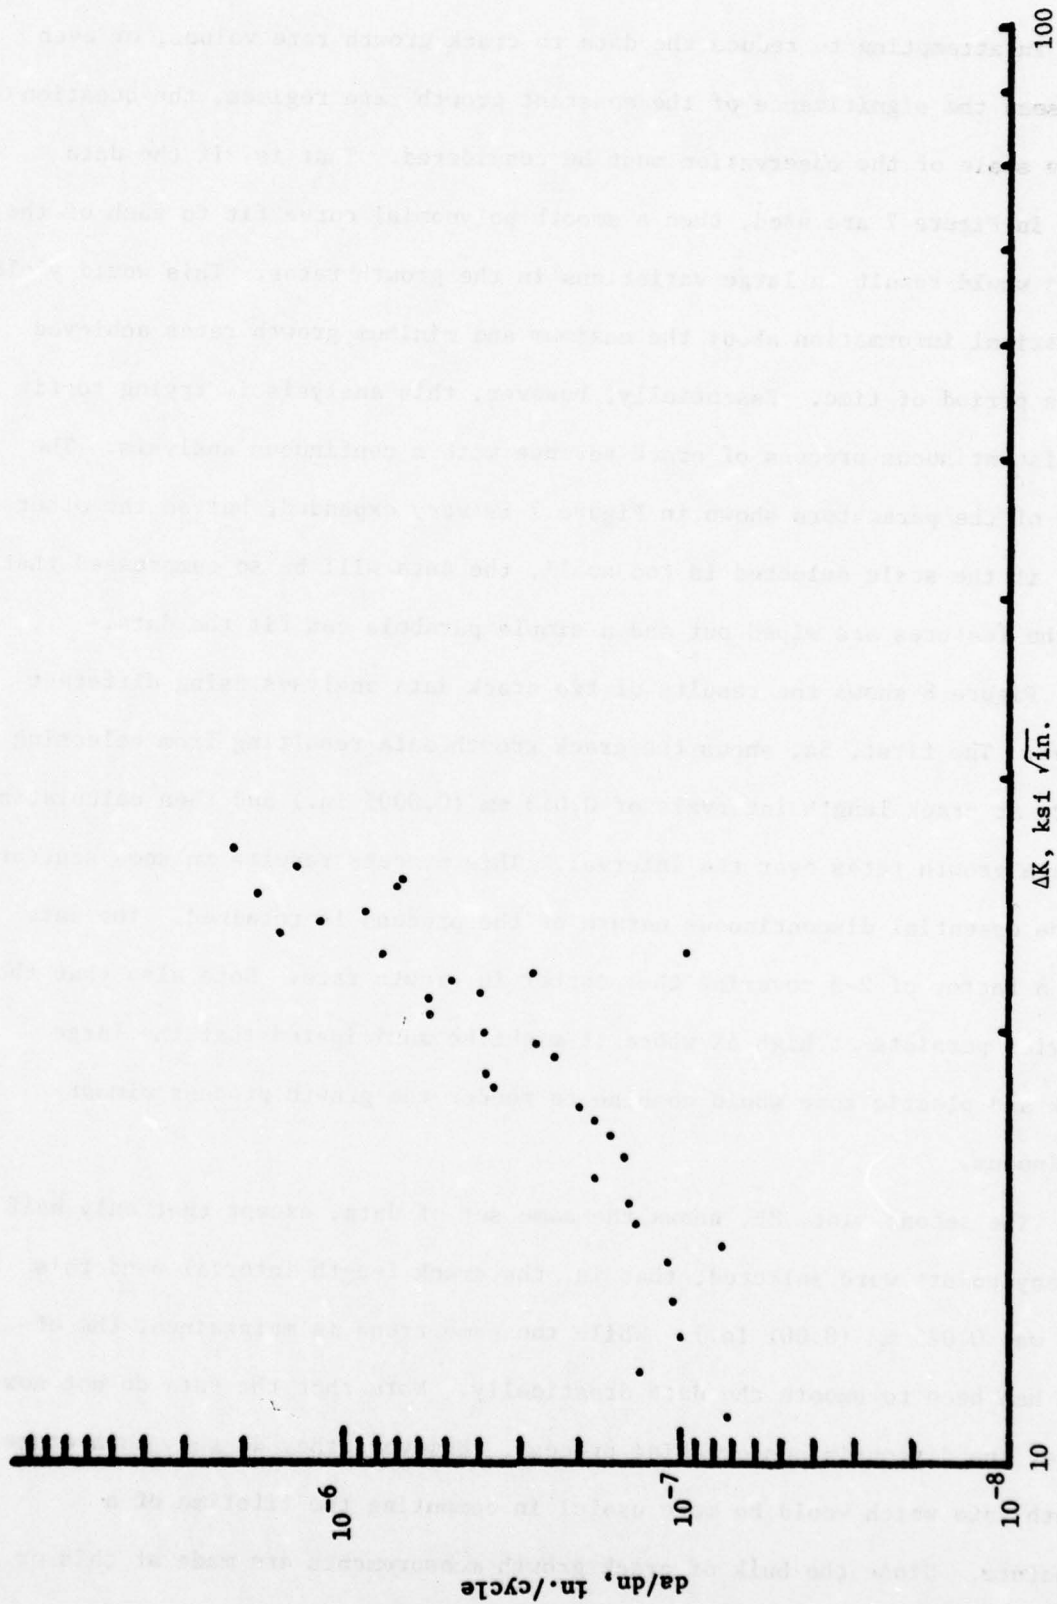
Figure 8a. Crack Growth Rate Vs Stress Intensity Factor
For Specimen 2, $R = 0.05$.
(See Table 2 For Test Parameters)

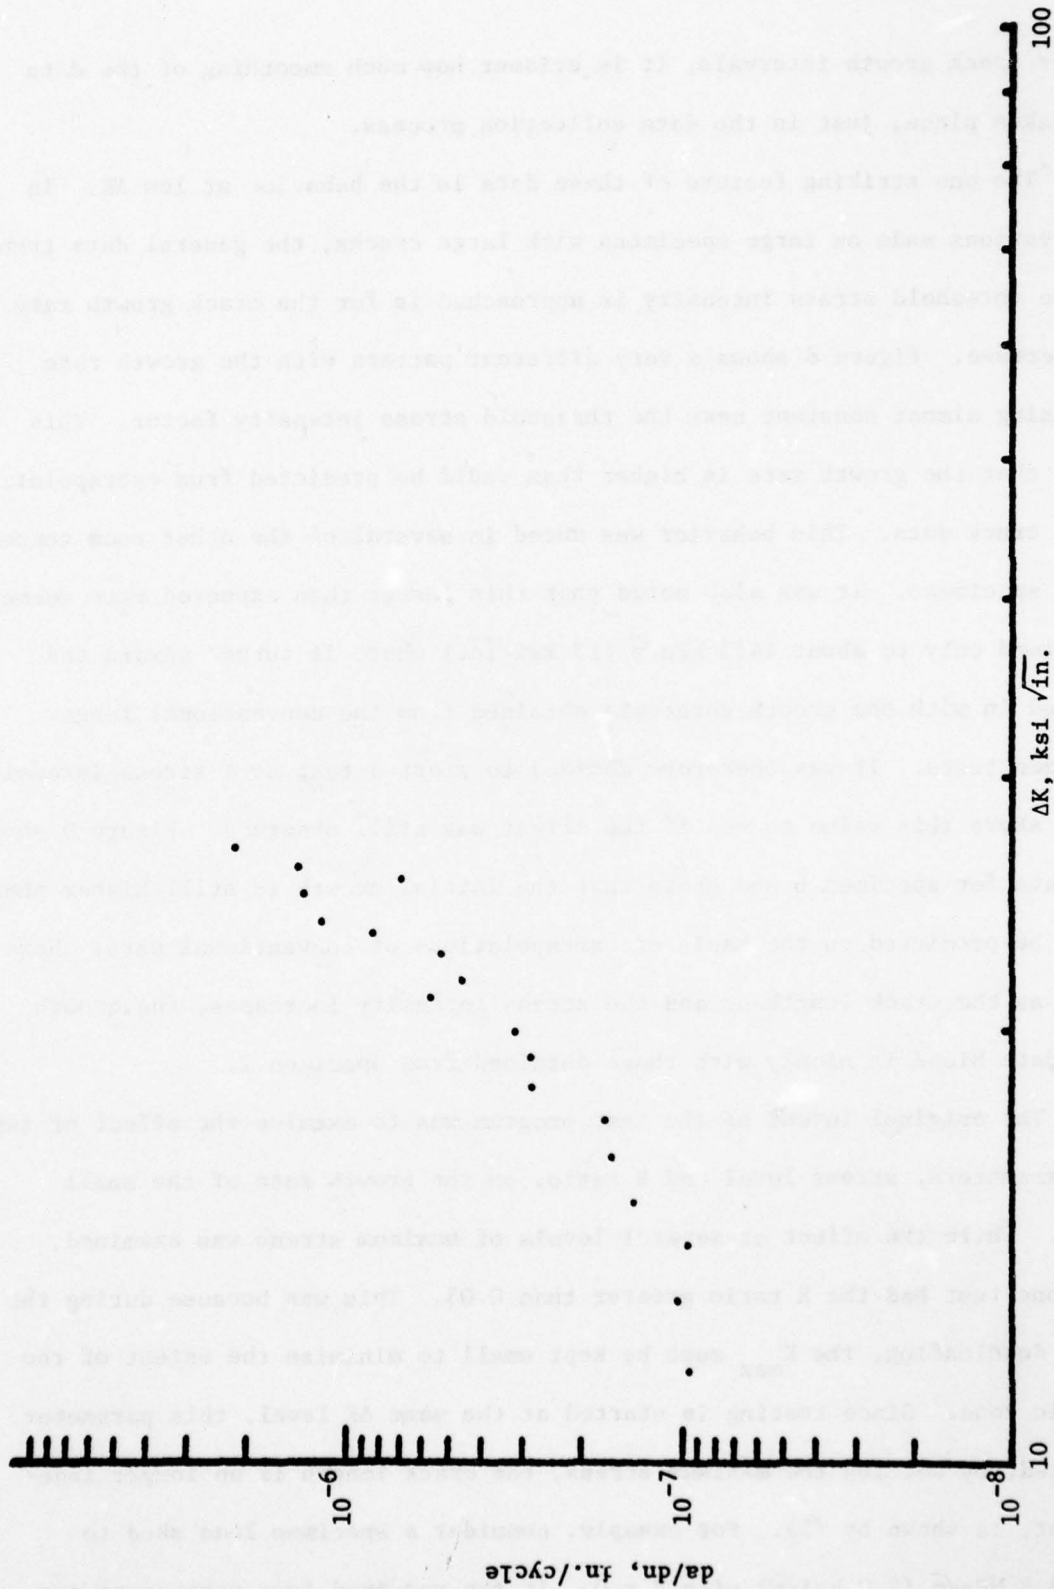
Figure 8b. Crack Growth Rate Vs Stress Intensity Factor
For Specimen 2, $R = 0.05$
(See Table 2 For Test Parameters)

The second plot, 8b, shows the same set of data, except that only half as many points were selected; that is, the crack length interval used this time was 0.025 mm (0.001 in.). While the same trend is maintained, the effect has been to smooth the data drastically. Note that the data do not now convey the discontinuous cracking process. However, they do show an average growth rate which would be more useful in computing the lifetime of a structure. Since the bulk of crack growth measurements are made at this or

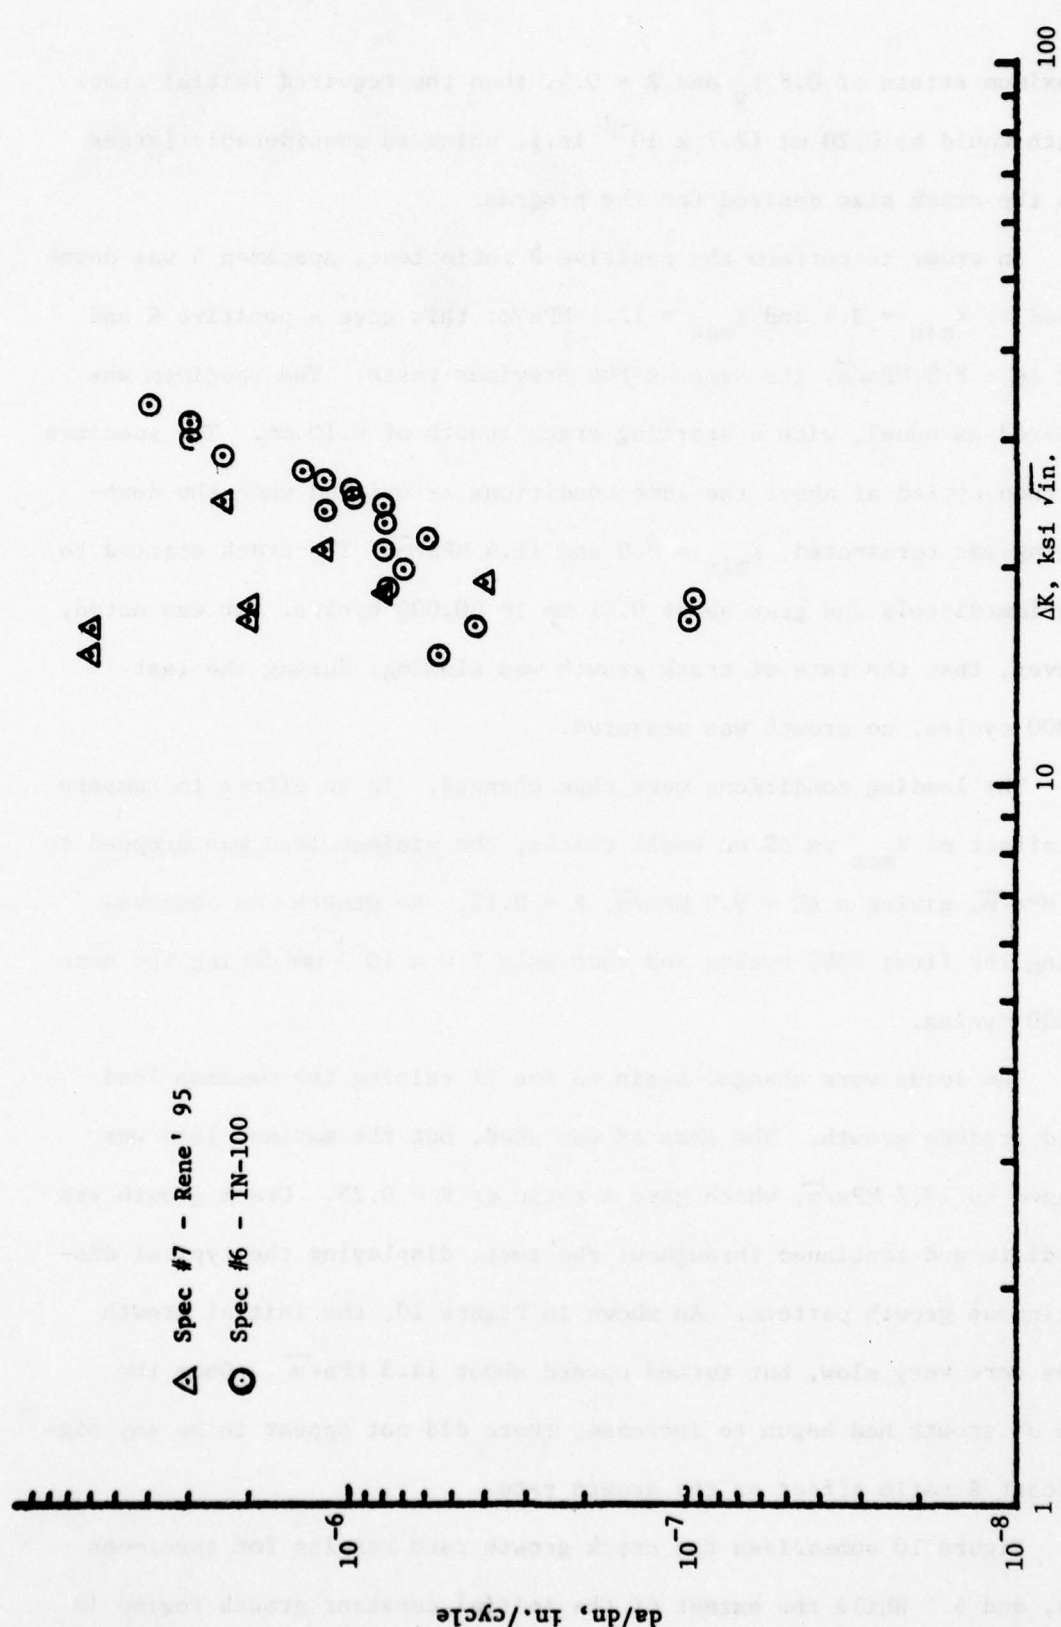
Figure 9. Crack Growth Rate Vs Stress Intensity Factor For Specimens 6 and 7. (See Table 2 For Test Parameters)

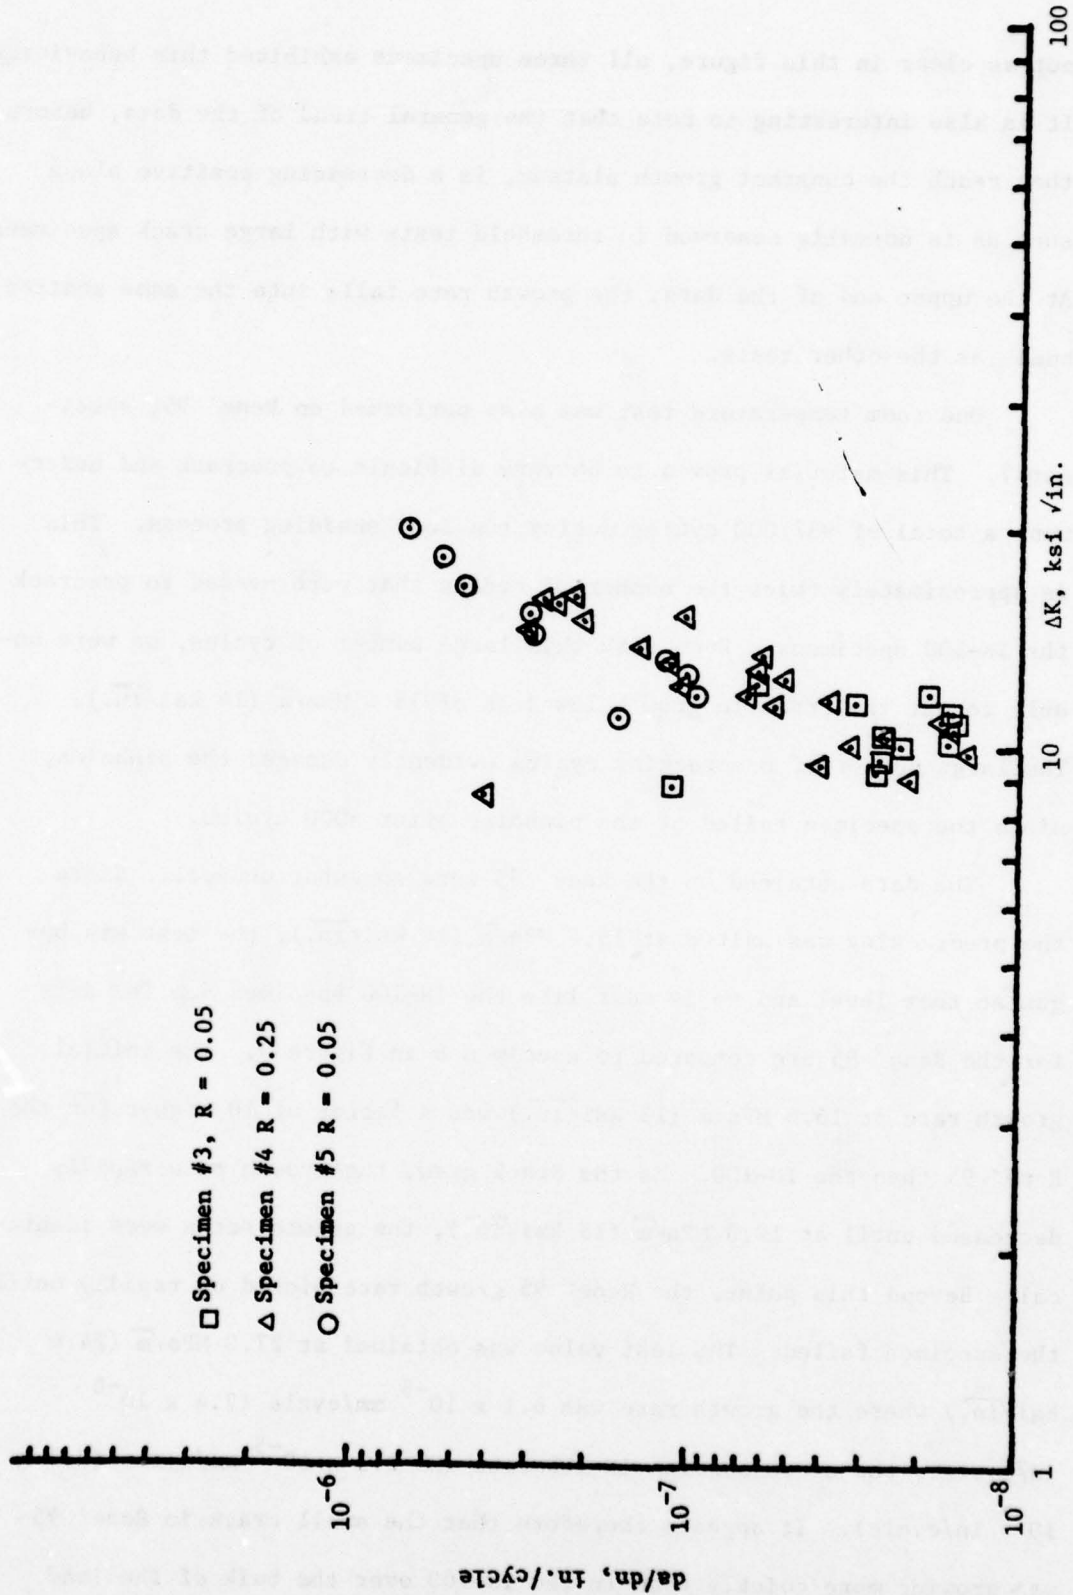
Figure 10. Crack Growth Rate Vs Stress Intensity Factor
 For Specimens 3, 4, and 5. (See Table 2
 For Test Parameters)

Figure 10 summarizes the crack growth rate results for specimens 3, 4, and 5. While the extent of the initial constant growth regime is

not as clear in this figure, all three specimens exhibited this behavior. It is also interesting to note that the general trend of the data, before they reach the constant growth plateau, is a decreasing positive slope such as is normally observed in threshold tests with large crack specimens. At the upper end of the data, the growth rate falls into the same scatter band as the other tests.

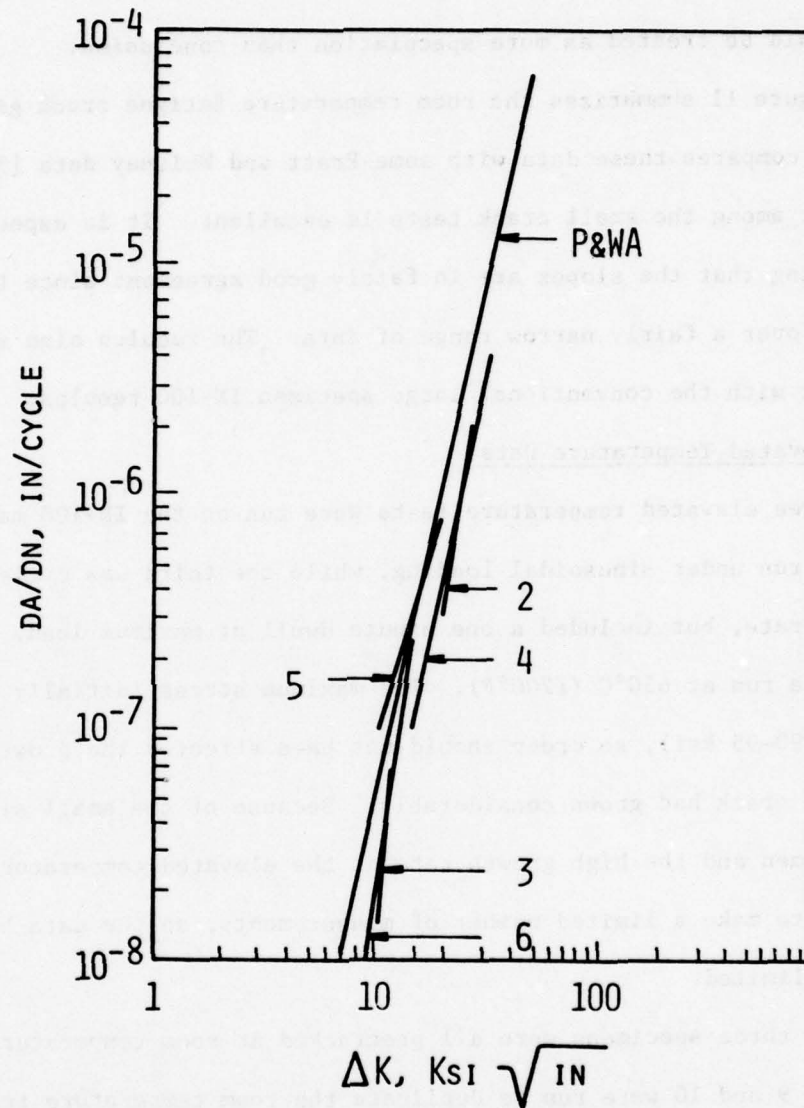
Figure 11. Summary of Room Temperature Fatigue
Crack Growth Rate Data (See Table 2
For Test Parameters)

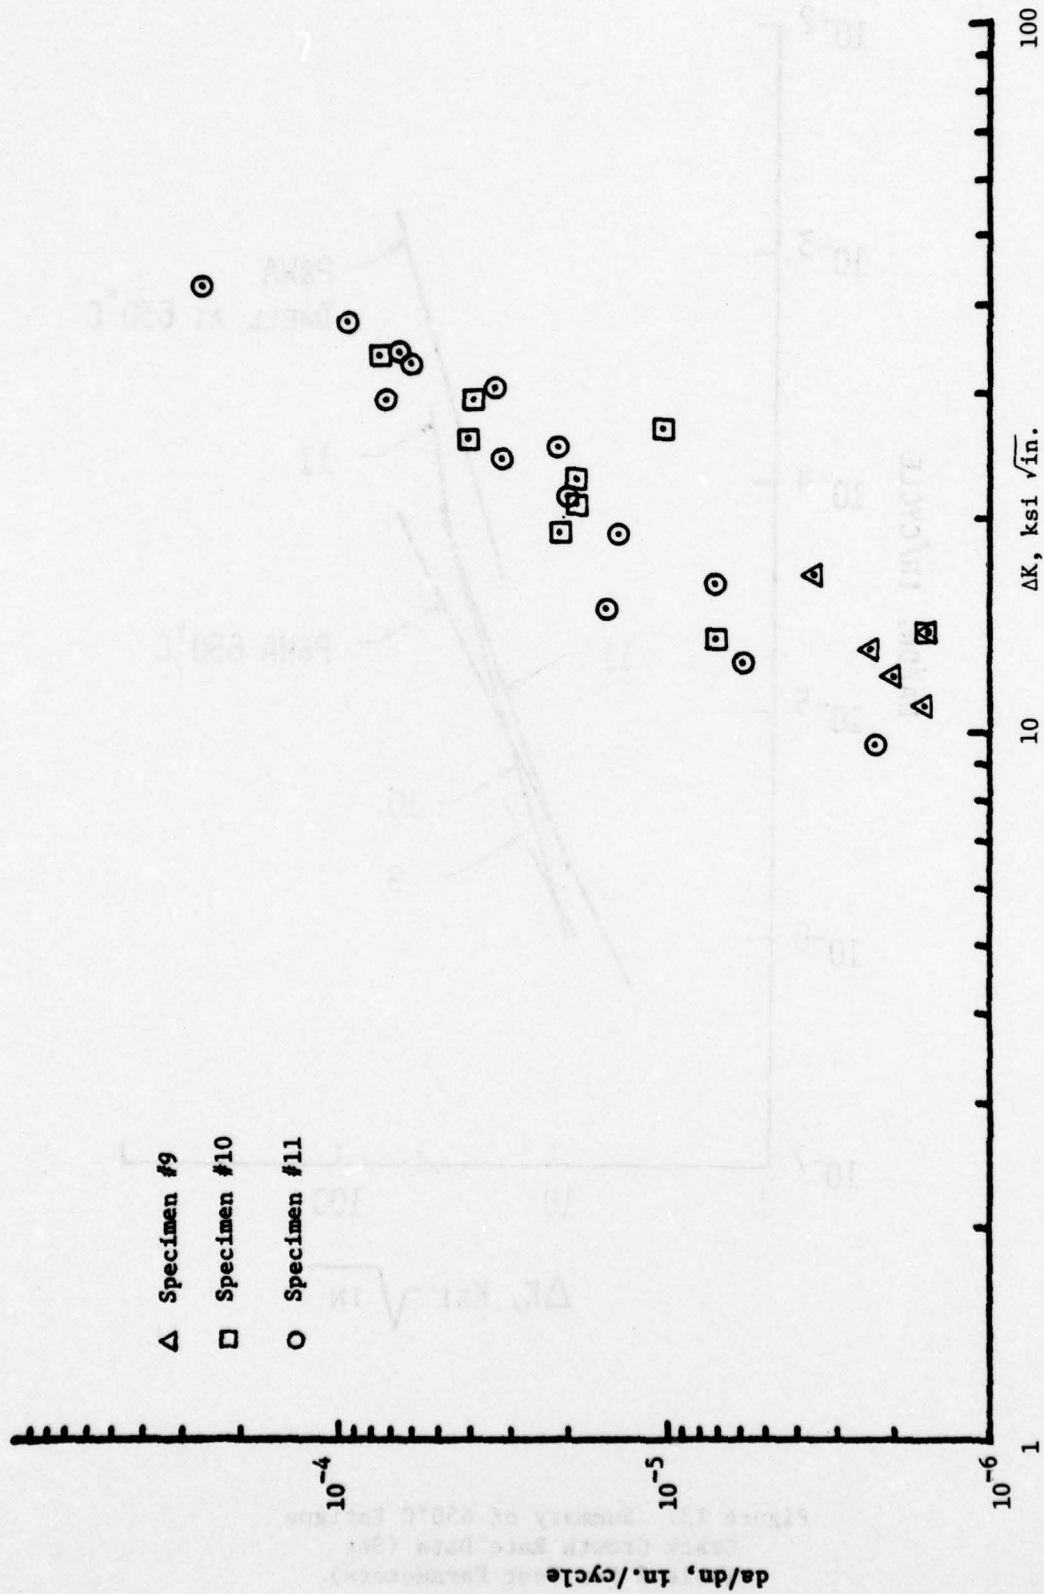
Figure 12. Crack Growth Rate Vs Stress Intensity Factor For Specimens 9, 10, and 11. (See Table 2 For Test Parameters)

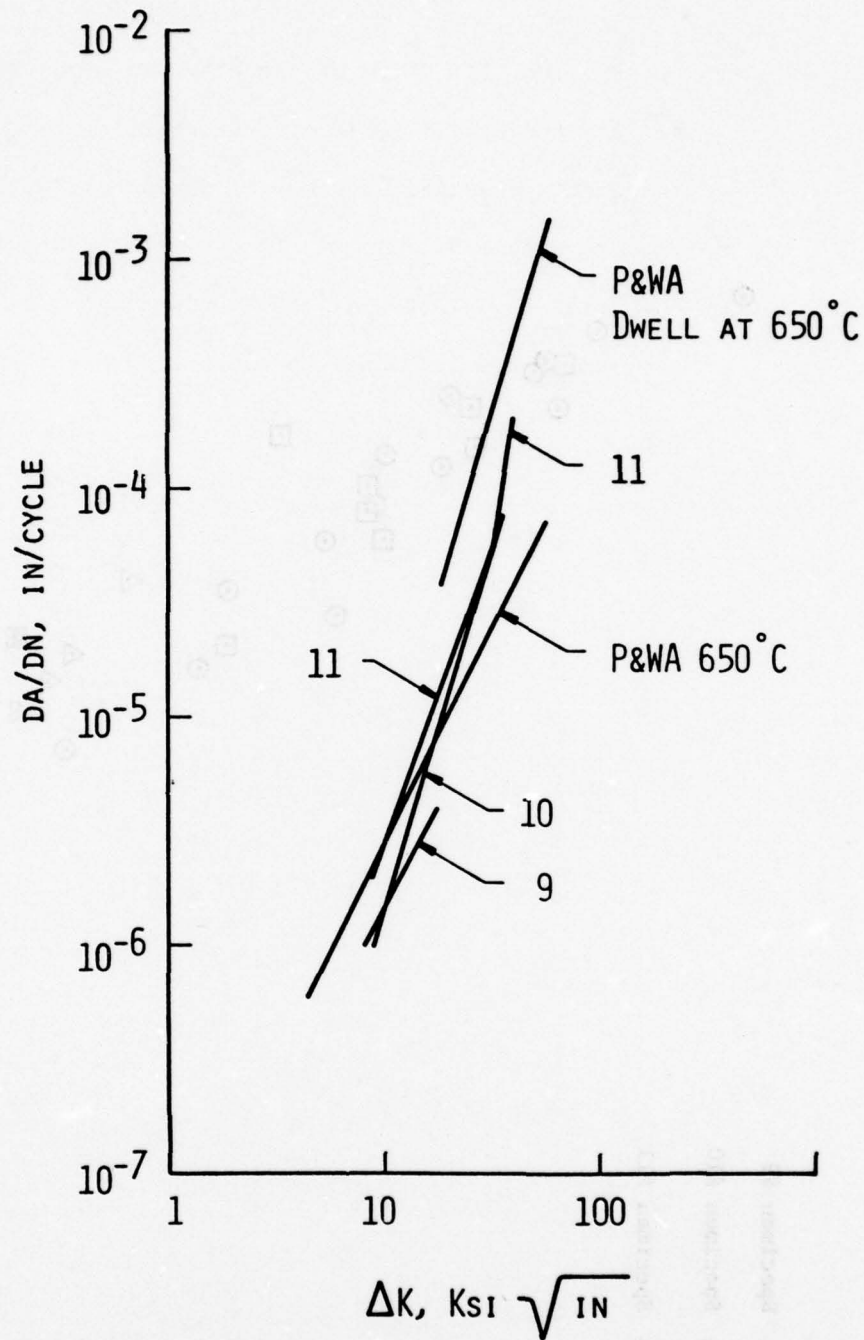
Figure 13. Summary of 650°C Fatigue Crack Growth Rate Data (See Table 2 For Test Parameters)

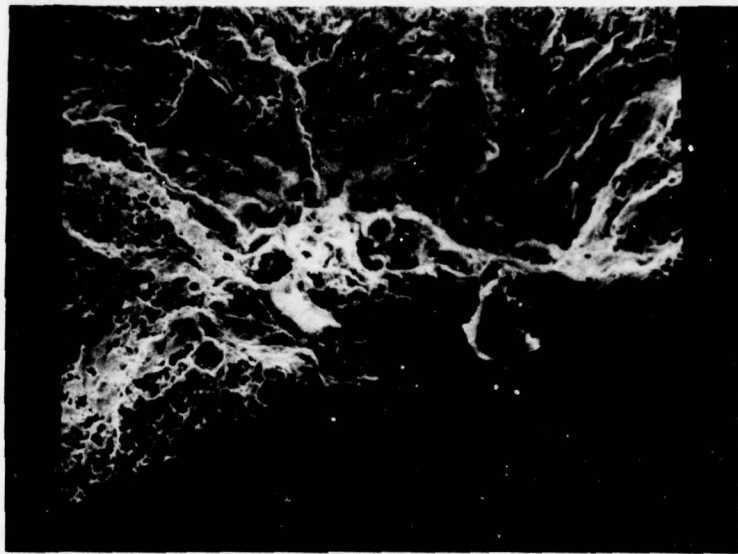
Figure 14. Initiation Site in LCF Specimen
Resulting From Unsintered Material. 600X

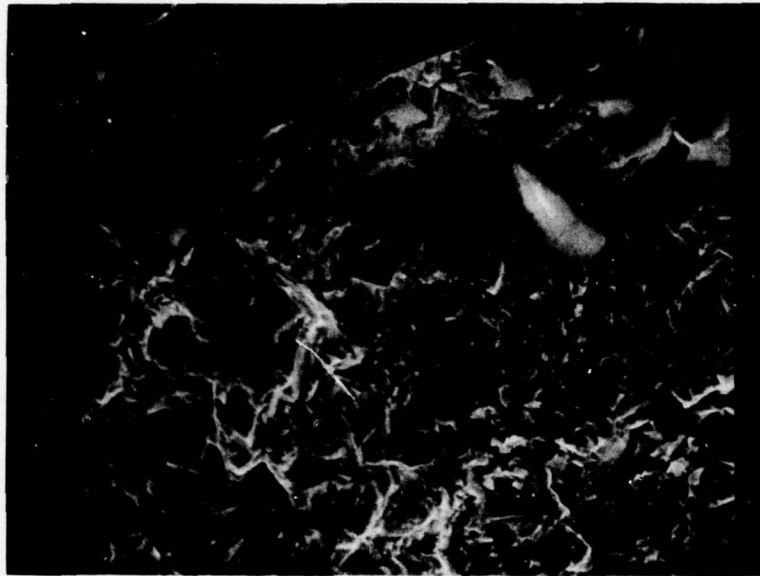
Figure 15a. Thumb Nail Fatigue Crack in LCF
Specimen. 26X

Figure 15b. Voids Located At Initiation Site.
1004X

Figure 15c. Close View of Voids. 2600X

crack shown in Figure 15a. Higher magnification views of the two voids are shown in Figure 15(b and c), in which fatigue striations also can be seen adjacent to the holes.

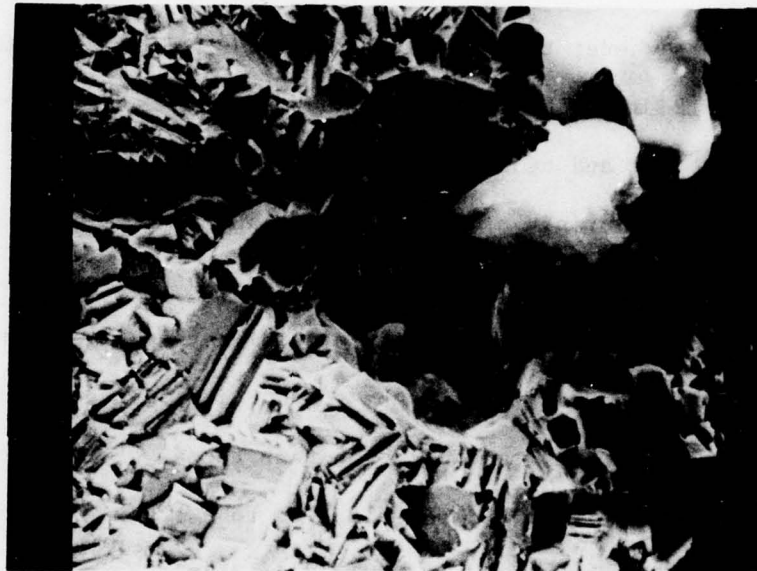
Figure 16. Void At Initiation Site of Razor Blade Specimen. 1700X

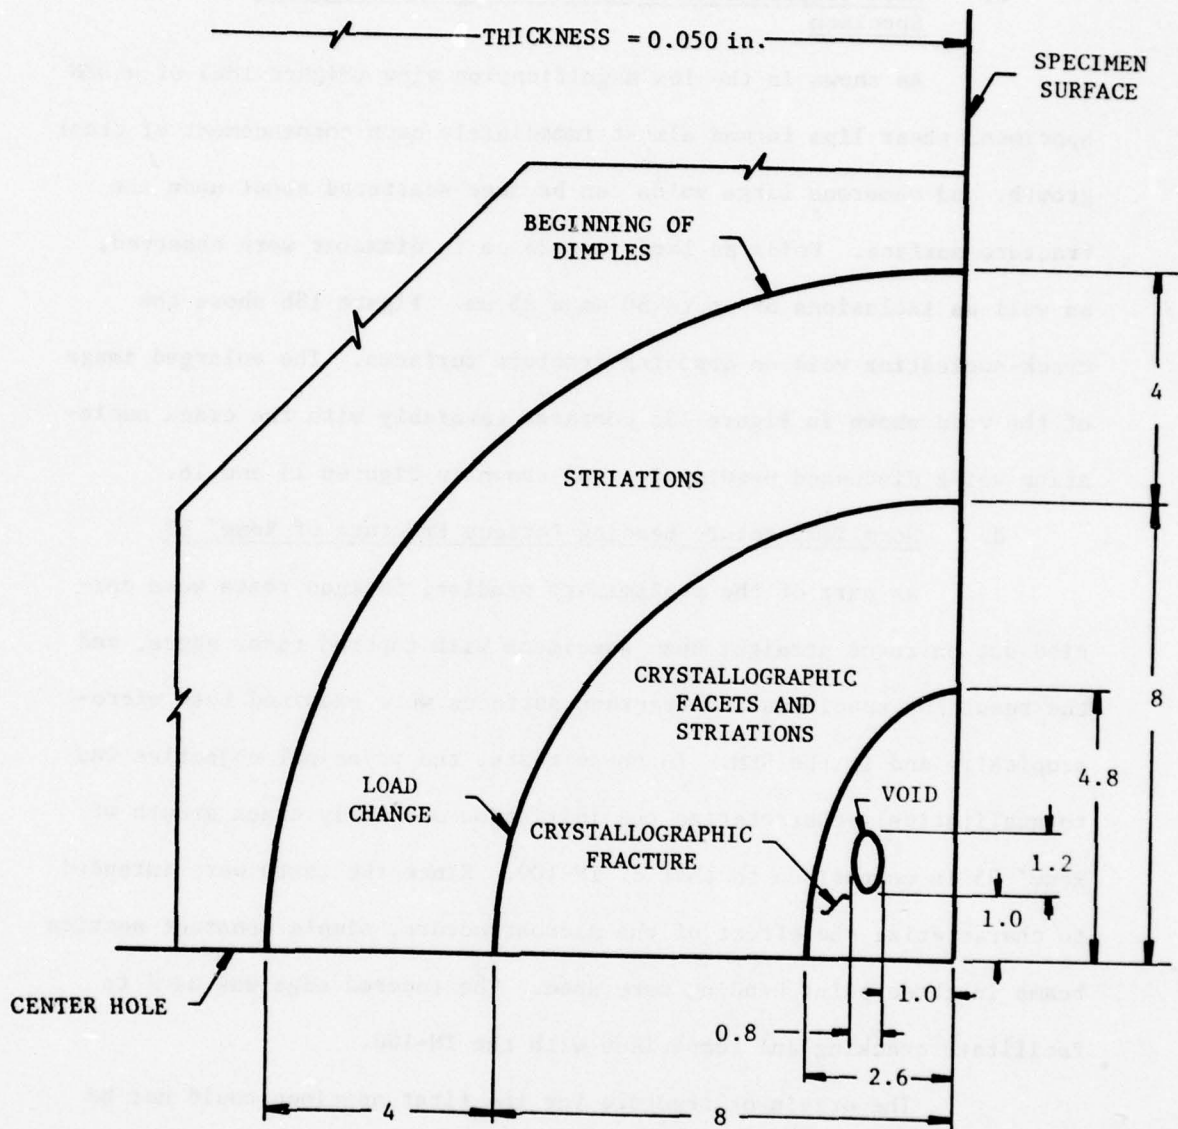
Figure 17. Sketch of Failure Surface of Razor Blade Specimen
(Dimensions In in. x 10⁻³)

As sketched in Figure 17, the region of crystallographic "cleavage" containing the initiating void first is followed by an area of mixed cleavage and striations, then by a region consisting principally of striations, and finally by the dimples characteristic of rapid crack growth. It will be shown that these transitional trends in fractography are repeated for the small crack tests.

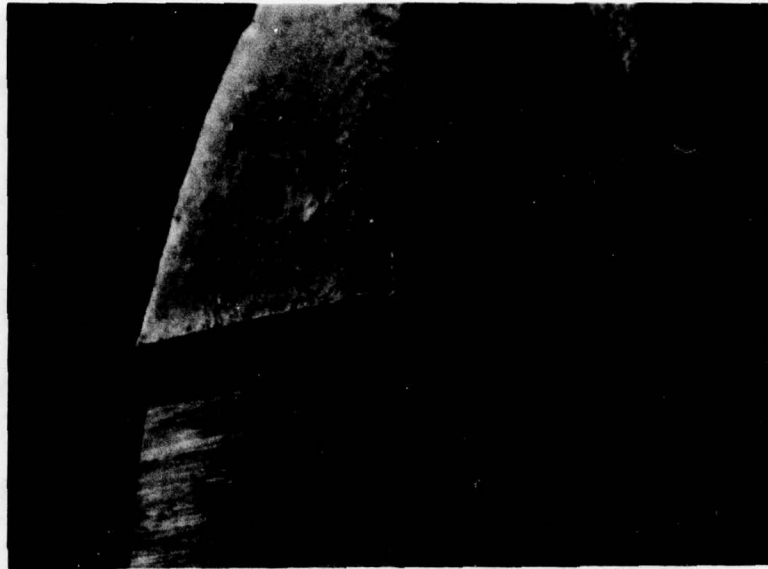
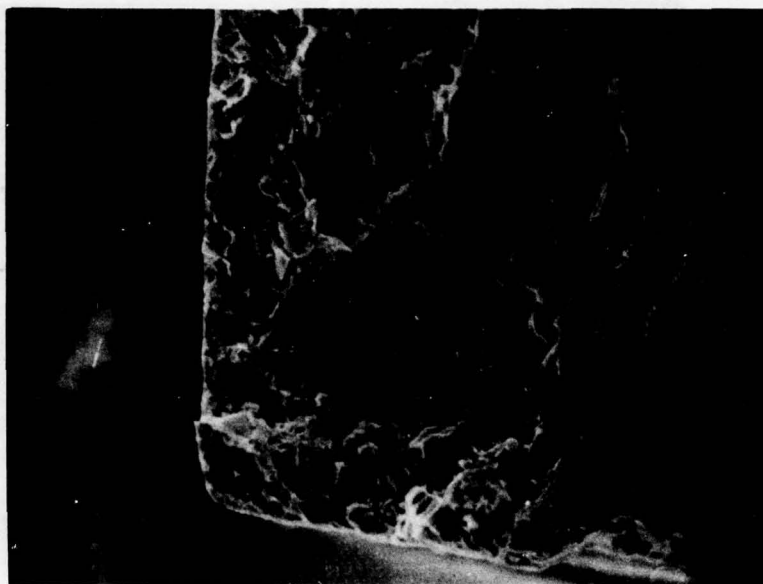
Figure 18a. Macroview of DEN Fatigue Surface.
28X

Figure 18b. Void At Origin of Failure in DEN
Specimen. 280X

Figure 18c. Closeup of Void. 1120X

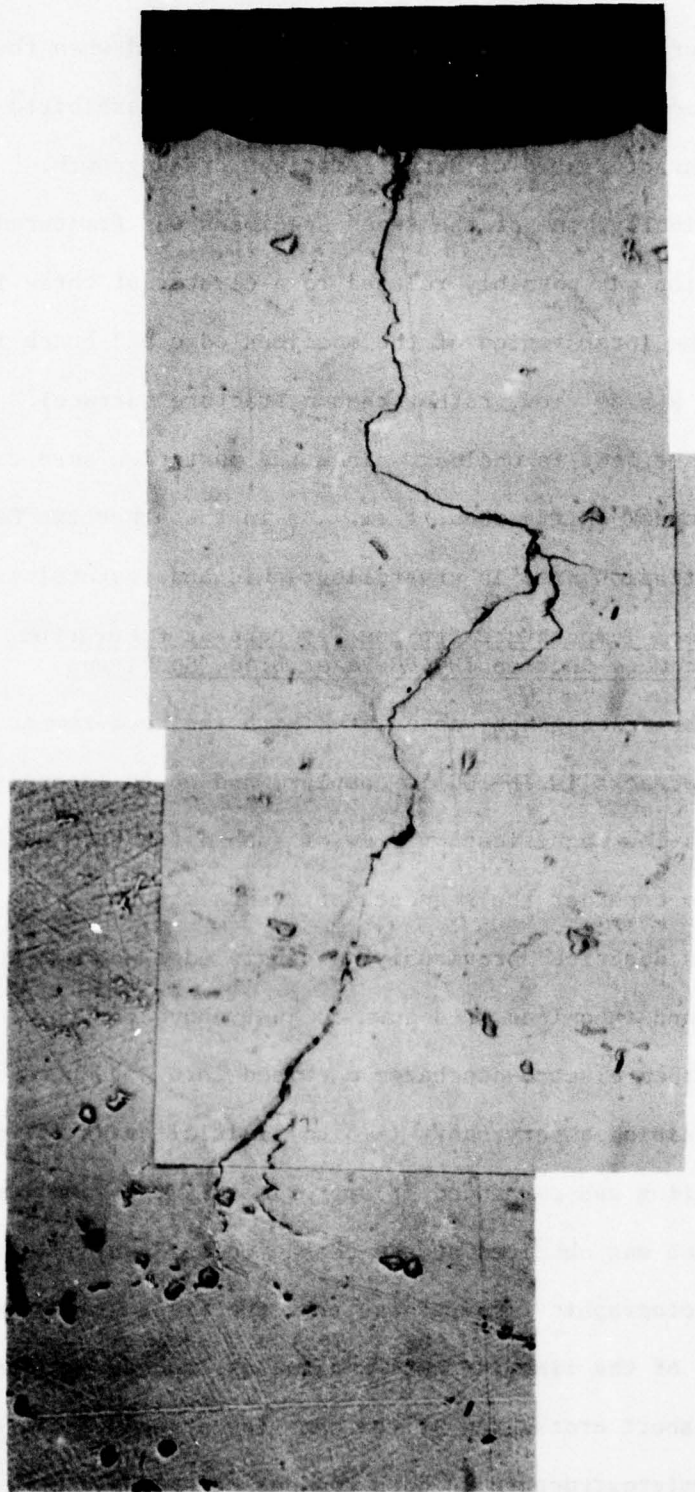
Figure 20. Initial Crack Found In Rene' 95 Bending Specimen
#3 After 3.0×10^6 Cycles, Left Side. 320X

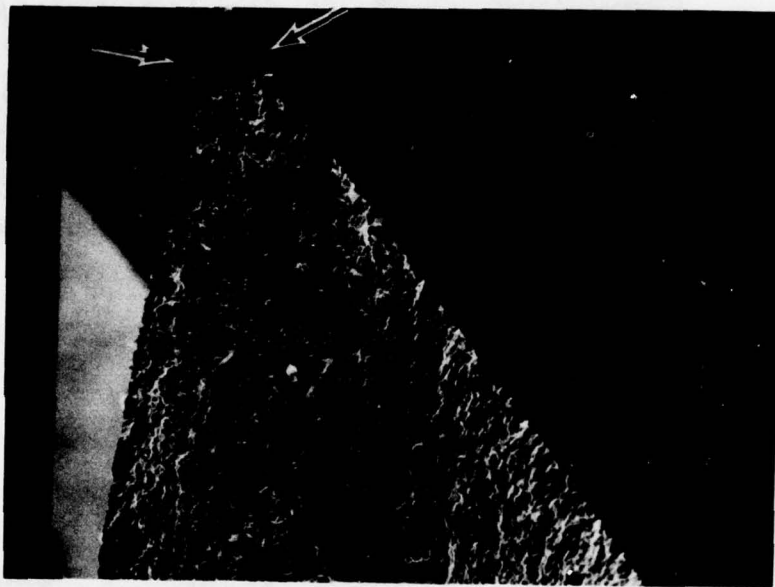
Figure 21. Fracture Surface of Room Temperature
Microcrack Specimen. 100X
Arrows Indicate Initial Crack Length.

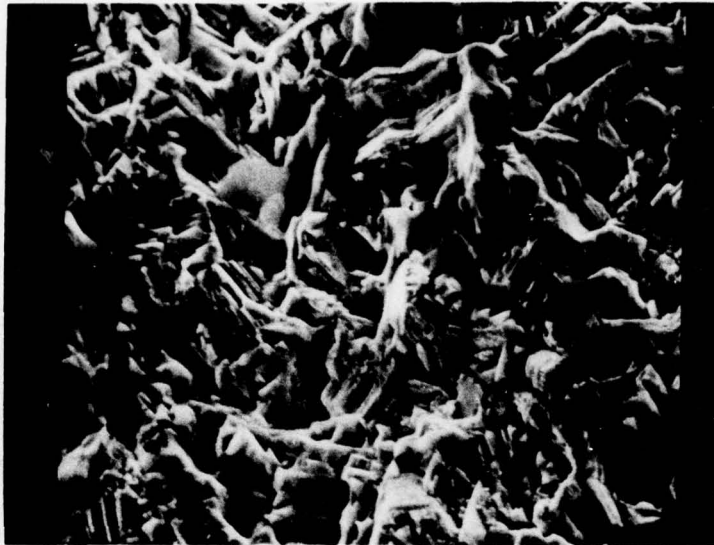
Figure 22a. Crystallographic Fatigue Surface of Room Temperature IN-100. 2500X

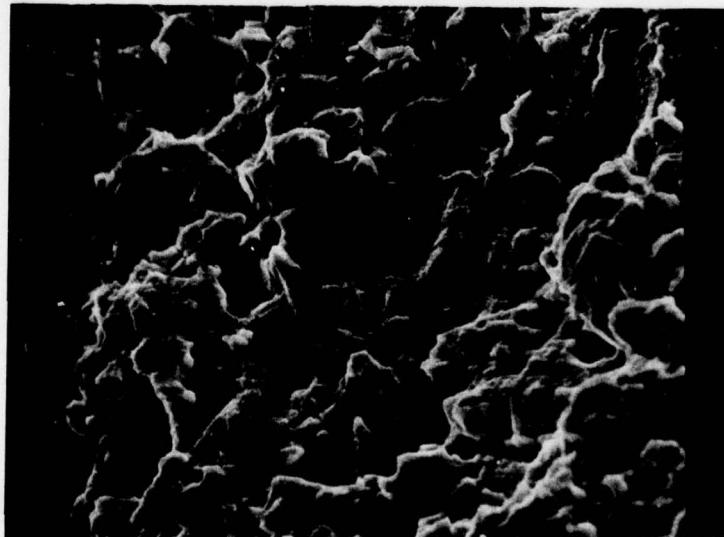
Figure 22b. Striations on IN-100 Fatigue Surface. 3000X

length, the fracture surface (with the exception of the regions along the edge of the specimen) is almost totally covered with striations (Figure 22b).
